FLOOD PREVENTION 2018

AUGUST 2018

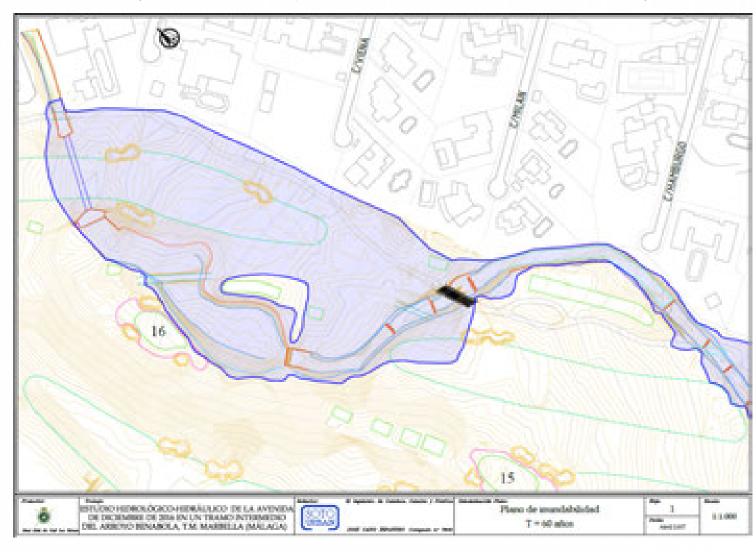
FLOODED AREAS HOLE 18

(EVERY 10-20 YEARS, BUT SIMILAR RAIN OCCURS EVERY 60 YEARS)

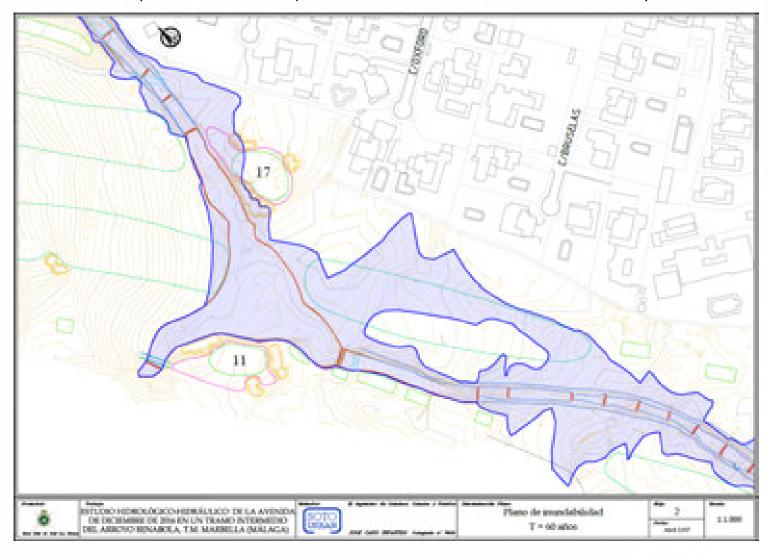
FLOODED AREAS HOLE 15-17

(EVERY 10-20 YEARS, BUT SIMILAR RAIN OCCURS EVERY 60 YEARS)

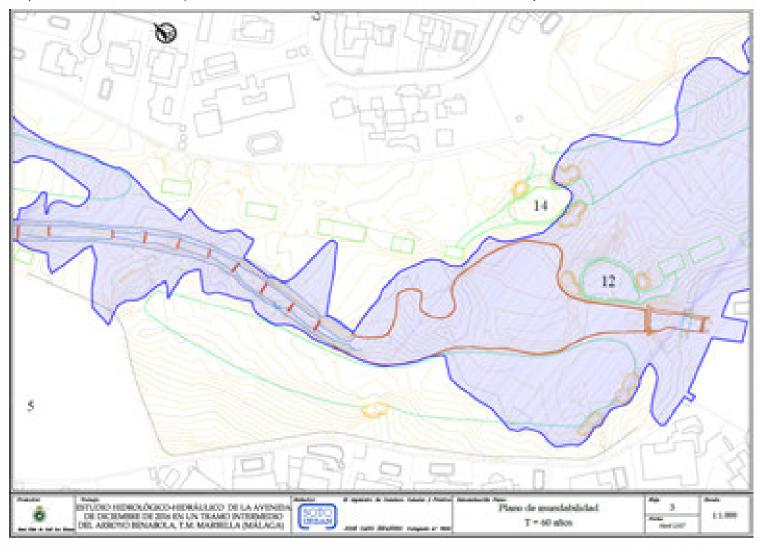
FLOODED AREAS HOLE 12-14

(EVERY 10-20 YEARS, BUT SIMILAR RAIN OCCURS EVERY 60 YEARS)

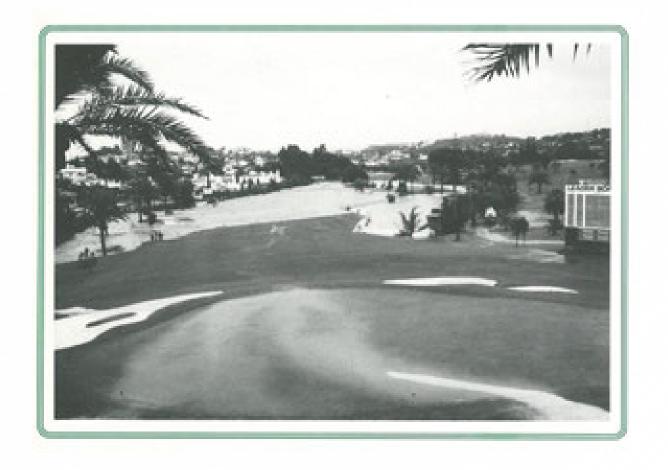
HISTORIC DATA

• DATA IS CONSISTENT WITH PAST OBSERVATIONS. SIMILAR FLOODING OCCURRED IN 1983

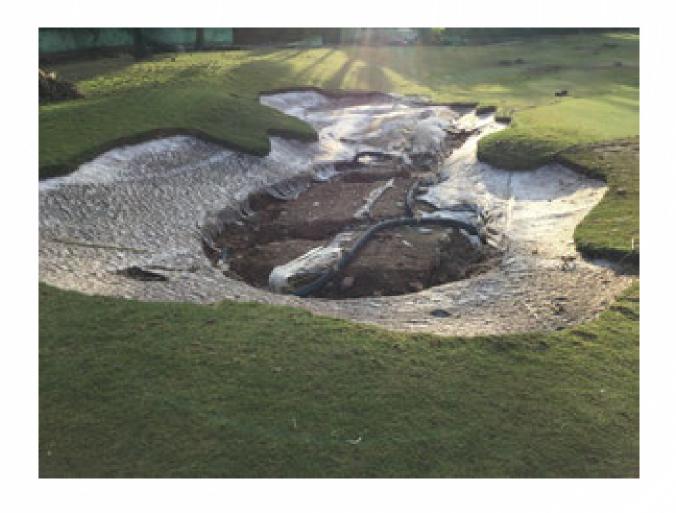
MEASURE 10: BEFORE

PROTECT BASE OF BUNKERS AND MAKE CLEANING OF CONTAMINATED SAND EASIER IN CASE OF FLOODS.

- INSTALATION OF A HARD BASE IN THE BUNKERS TO PROTECT DRAINAGE IN A FLOOD EVENT. INSTALATION OF CAPILARY CONCRETE IN EVERY BUNKER IN THE COURSE
- THE SYSTEM ALLOWS FOR AN EASY CLEANING OF CONTAMINATED SAND WITHOUT DISRUPTING THE BASE OF BUNKERS AND DRAINAGE.

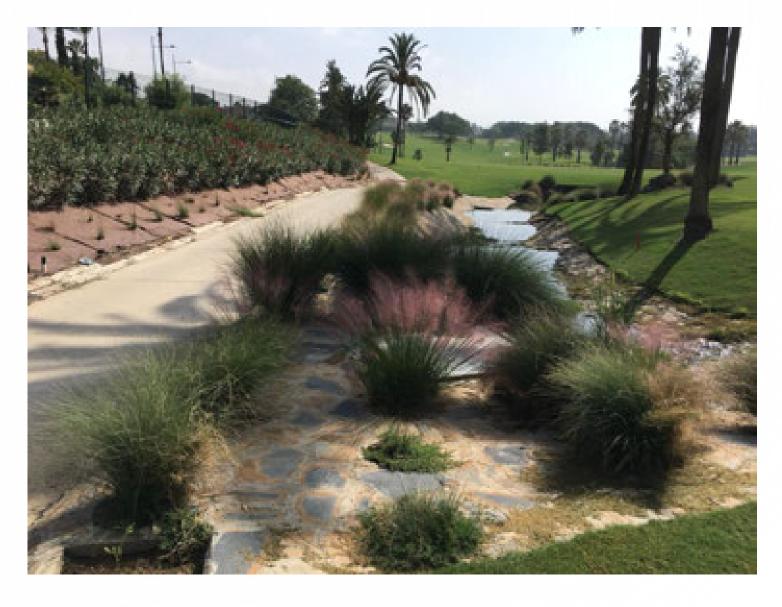
MEASURE 12: AFTER

- GOAL:
- AVOID EROSION IN THE BANKS AT HOLE 2

- SOLUTION:
- LANDSCAPING PROJECT TO STABILISE THE BANK.
- STONE COVER ALONG THE CREEK AND IMPROVEMENTS IN THE CART PATH.

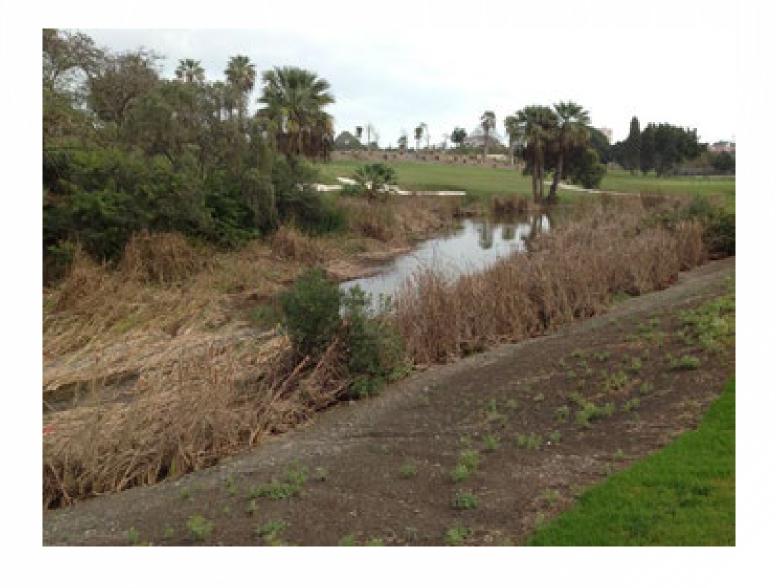
MEASURE 14: BEFORE

- GOAL:
- IMPROVE WATER FLOW IN THE LAKE

- SOLUTION:
- CLEAN UP OF LAKE BOTTOM, GETTING RID OF AENEAS THAT WERE REDUCING WATER FLOW.

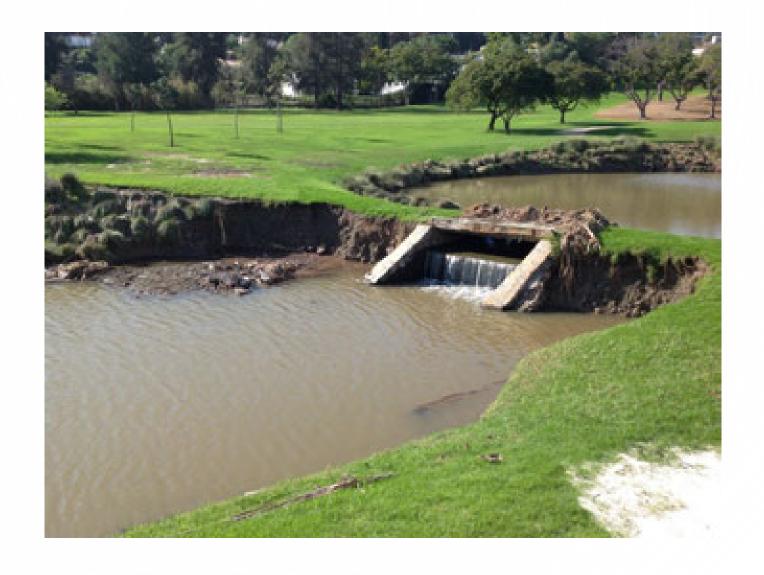
MEASURE 15: BEFORE

- GOAL:
- PROTECTION OF OVERFLOW AND SIDE BANKS OF THE CREEK TOWARD 6 FAIRWAY
- SOLUTION:
- PROTECTION OF BOTH SIDES OF THE BRIDGE WITH A STONE WALL.
- REFURBISHMENT OF BOTH SIDES OF THE CREEK WITH STONE COVER.

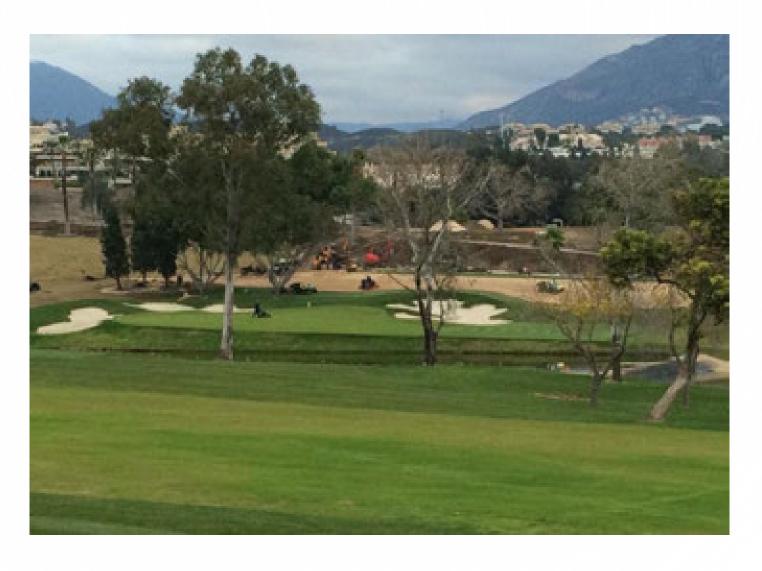
MEASURE 16: BEFORE

- GOAL:
- PROTECT THE BANK OF THE LAKE AT GREEN 6
