FLOOD PREVENTION 2018

AUGUST 2018

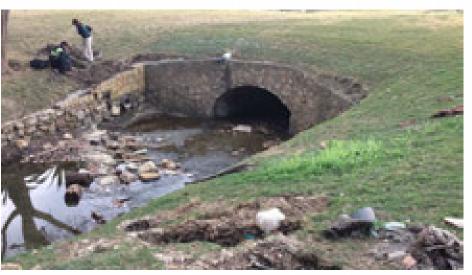
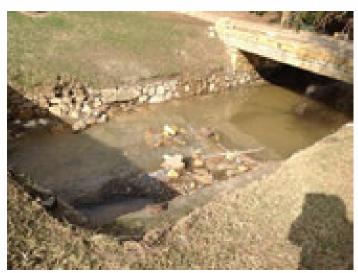
MEASURE 1: BEFORE

- GOAL:
- HOLD THE WATER IN BENABOLA CREEK BEFORE THE PIPE THAT CROSSES HOLE 18.

- SOLUTION:
- RAISING STONE WALLS TO HOLD BACK THE FLOODS.

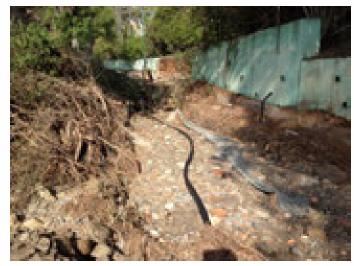
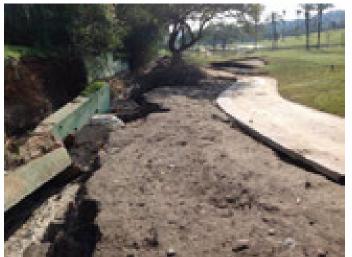
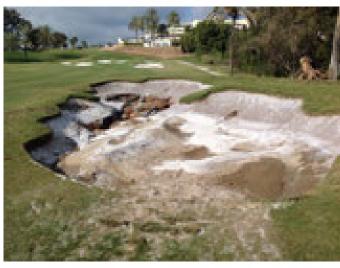
MEASURE 2: BEFORE

PREVENT EROSIONS AT THE ENTRANCE OF BENABOLA CREEK INTO THE COURSE, CAUSED BY THE FUNNEL CREATED IN THE PIPE THAT CROSSES HOLE 18

REMOVAL OF PIPE WOULD CHANGE THE DESIGN AND WOULD BE QUITE EXPENSIVE. DAMAGE IS REDUCED RESHAPING THE CART PATH TO HOLD WATER TOWARDS THE TEES, AND PLANTING THE SIDES OF THE HOLE WITH TURF TO AVOID EROSION.

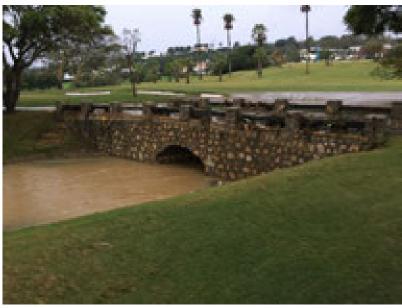
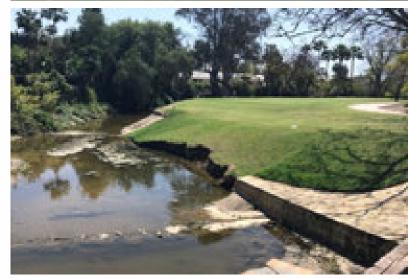
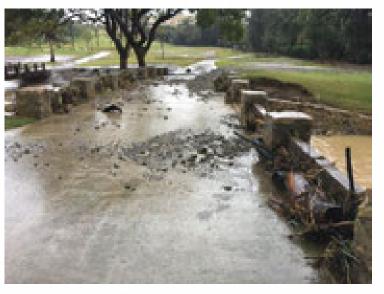
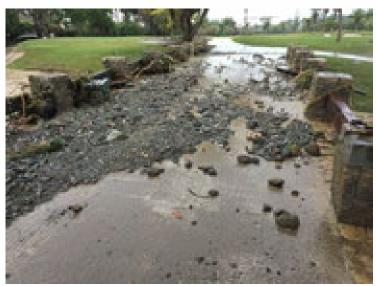
MEASURE 3: BEFORE

- GOAL:
- PREVENT FLOODS IN TEE 18

- SOLUTION:
- THE SECTION OF THE CREEK AFTER TEE 18 IS PROTECTED WITH STONE WALLS.

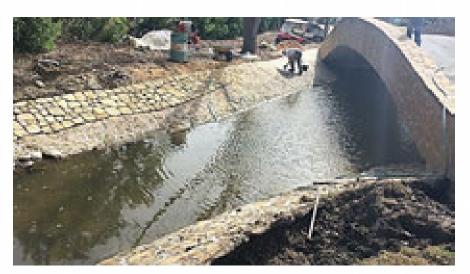
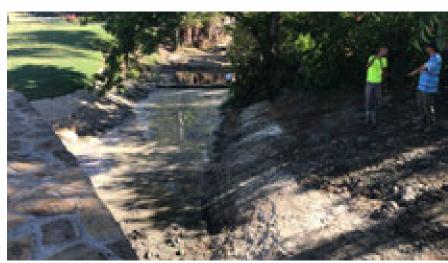
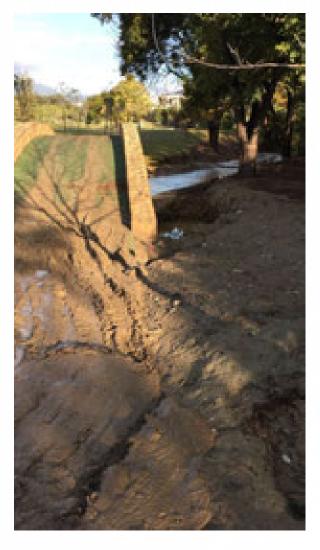
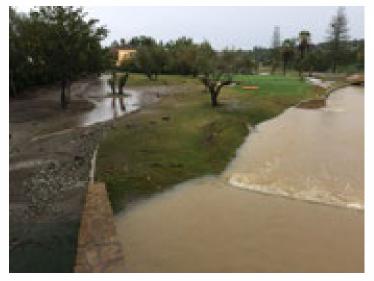
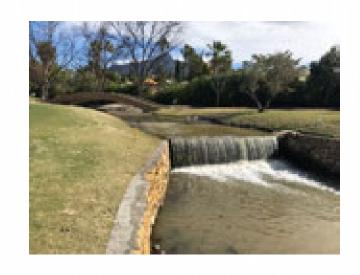
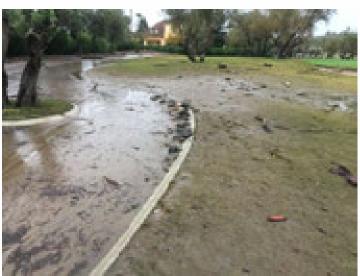
MEASURE 4: BEFORE

- GOAL:
- PREVENT FLOODS IN GREEN 17

- SOLUTION:
- INSTALL A STONE WALL ON THE LEFT SIDE, BEFORE AND AFTER THE BRIDGE, TO RAISE THE OVERFLOW HEIGHT. THE DEBRIS FROM CLEANING THE LAKE AT HOLE 15 WILL BE USED AS INFILL.
- LAST DAMN WILL BE LOWERED.
- A CREAGER SHAPE IS USED IN THE NEW DAMN TO IMPROVE WATER EVACUATION.

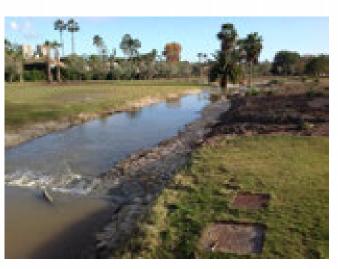
MEASURE 6: BEFORE

- GOAL:
- PREVENT FLOODS ON THE FAIRWAY

- SOLUTION:
- THE SECTION OF THE BENABOLA CREEK ON THE RIGHT SIDE IS PROTECTED WITH STONE WALLS.

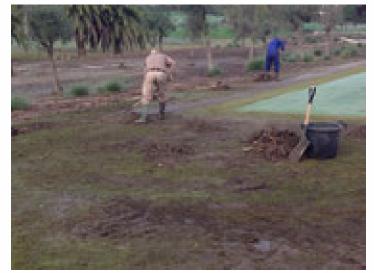
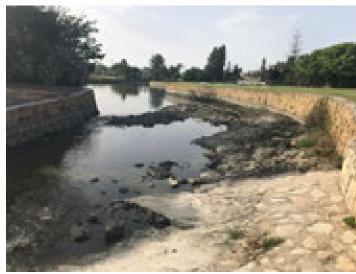
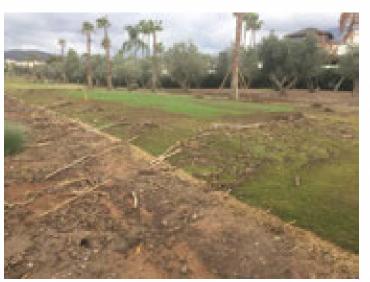
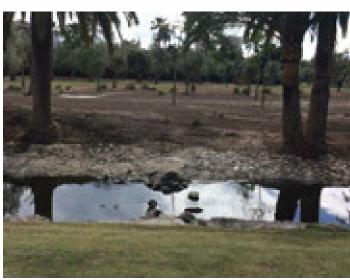
MEASURE 7: BEFORE

- GOAL:
- PREVENT FLOODS IN TEES 15

- SOLUTION:
- RAISING LEFT SIDE WITH SOIL

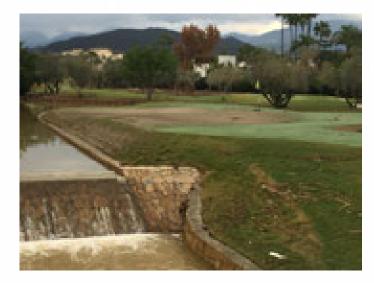
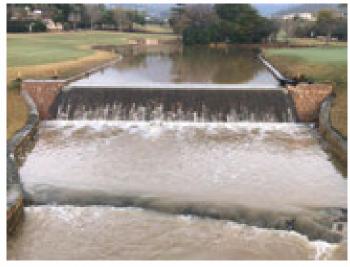
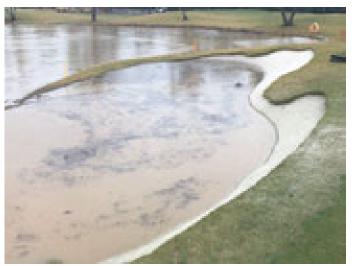
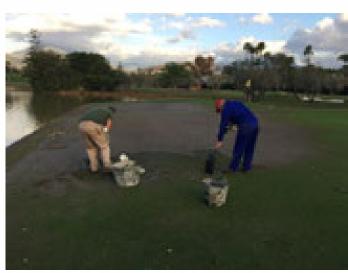
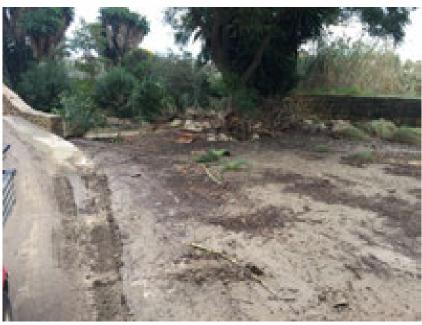
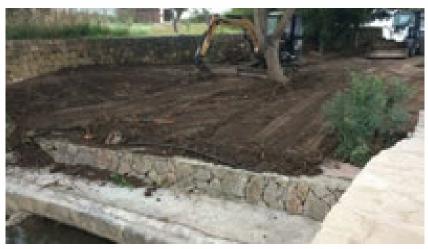
MEASURE 8: BEFORE

- GOAL:
- PREVENT FLOODS IN GREEN 12

- SOLUTION:
- MAKE THE DAMN WIDER IN THE LAKE AT HOLE 12. EVACUATION FLOW WILL IMPROVE IN THIS LAKE
- DAMN HEIGHT IS DROPPED 30 CM TO LOWER THE LEVEL OF WATER DURING FLOODS.
- A CREAGER SHAPE IS USED IN THE NEW DAMN TO IMPROVE WATER EVACUATION.
- YUCAS AND SHRUBS ARE REMOVED ON

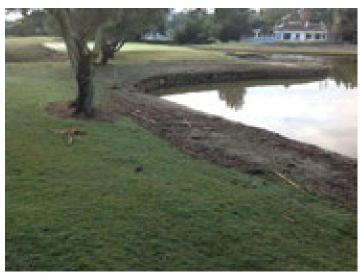
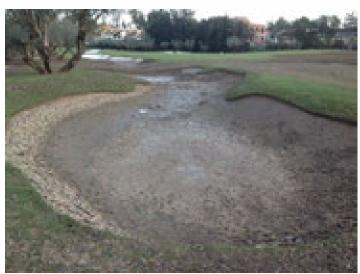
MEASURE 9: BEFORE

- GOAL:
- PREVENT FLOODS IN HOLES 13-14

- SOLUTION:
- RAISE GROUND LEVEL BETWEEN GREENS 12 AND 14 TO HOLD WATER FROM LAKE WHEN WATER LEVEL INCREASES, PREVENTING FLOODS TOWARD LOWER HOLES IN THE COURSE.

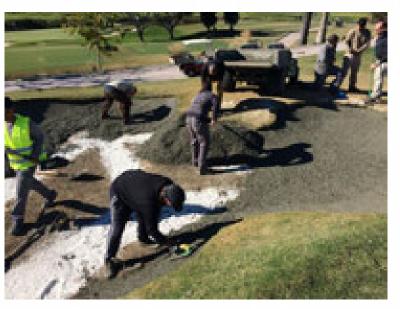
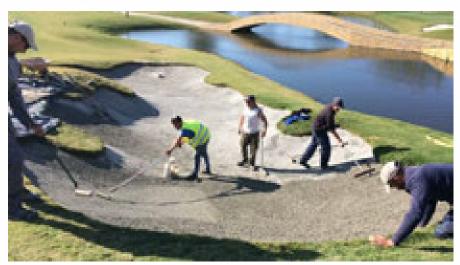
MEASURE 10: AFTER

PROTECT BASE OF BUNKERS AND MAKE CLEANING OF CONTAMINATED SAND EASIER IN CASE OF FLOODS.

- INSTALATION OF A HARD BASE IN THE BUNKERS TO PROTECT DRAINAGE IN A FLOOD EVENT. INSTALATION OF CAPILARY CONCRETE IN EVERY BUNKER IN THE COURSE
- THE SYSTEM ALLOWS FOR AN EASY CLEANING OF CONTAMINATED SAND WITHOUT DISRUPTING THE BASE OF BUNKERS AND DRAINAGE.

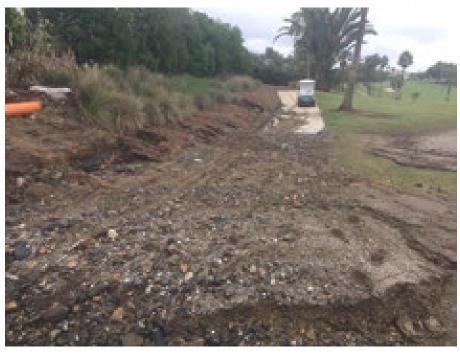
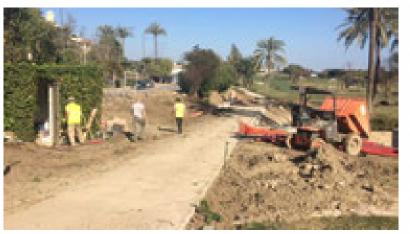
MEASURE 11: BEFORE

- GOAL:
- PROTECT HOLE 2 FROM FLOODING COMING FROM LOS NARANJOS' LAKE.

- SOLUTION:
- INSTALATION OF A CONCRETE WALL ALONG THE STREET.
- WATER ALONG AVENIDA DEL PRADO IS DIRECTED INTO THE CREEK.
- IMPROVEMENTS OF OVERFLOW AT LOS NARANJOS' LAKE BY MUNICIPALITY
- SIDEWALK IS CONDITIONED TO HOLD WATER

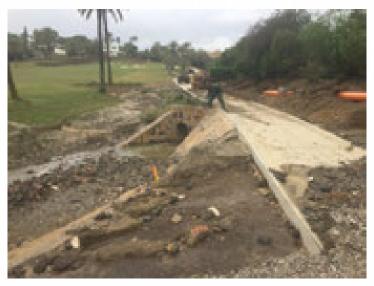
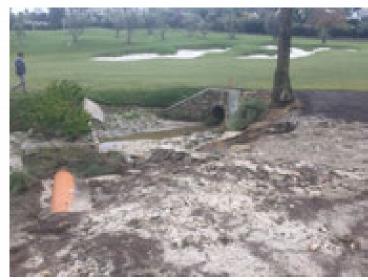
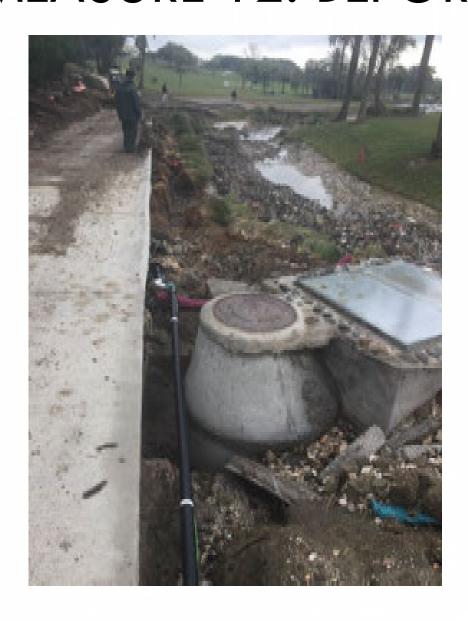
MEASURE 12: BEFORE

- GOAL:
- AVOID EROSION IN THE BANKS AT HOLE 2

- SOLUTION:
- LANDSCAPING PROJECT TO STABILISE THE BANK.
- STONE COVER ALONG THE CREEK AND IMPROVEMENTS IN THE CART PATH.
