MAINTENANCE WEEK

JULY 2018

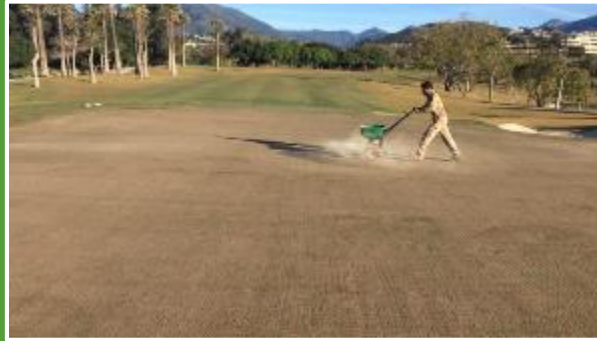
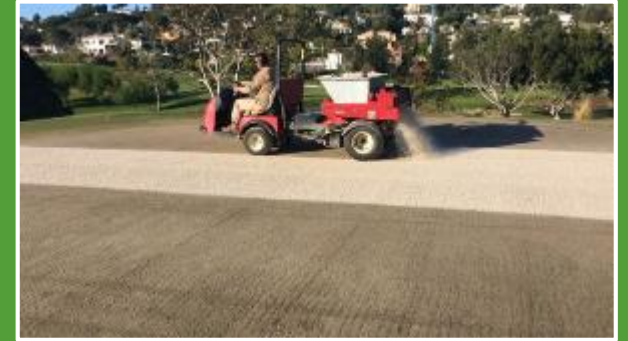
WORK ON GREENS

GYPSUM IS APPLIED TO REDUCE SALINITY IN THE SOIL

VERTICUT TO REDUCE THATCH AND PROVIDE A FIRM SURFACE

SOLID AERATION IN THE ENTIRE AREA WITH 15 MM TINES AND A 9 CM DEPTH

TOPDRESSING WITH SAND

BRUSH, BLOWERS AND ROLLERS AS NEEDED TO CLEAN THE PLAYING SURFACE

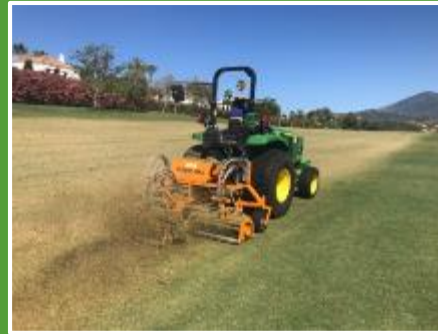
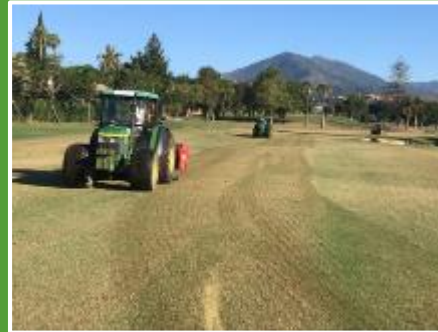
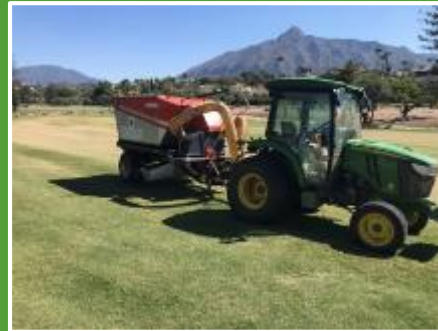
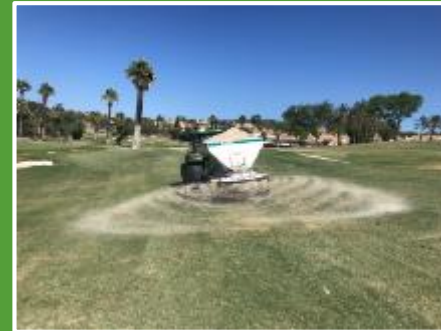
WORK ON FAIRWAYS AND ROUGHS

VERTICUT IS DONE IN ORDER TO REDUCE THATCH AND PROMOTE VERTICAL GROWTH OF THE GRASS AND A FIRM PLAYING SURFACE

SOLID AERATION OF THE AREA WITH 19MM TINES AND A 12CM DEPTH. SPECIAL ATTENTION IS GIVEN TO THE FAIRWAYS THAT RECEIVED MUD IN THE 2016 FLOODS

HOLLOW AERATION OF THE BACK NINE ROUGHS THAT HAVEN'T GOT SANDY SOIL WITH 19MM TINES AND A 10CM DEPTH. THIS WILL RELIEVE COMPACTION AND ALLOW FLOW OF OXYGEN AND WATER TO THE ROOT ZONE

TOPDRESSING WITH SAND, USING FIRST THE OLD SAND FROM BUNKERS PILED BEHIND THE DRIVING RANGE

CLEANING OF DEBRIS FROM VERTICUT AND AERATION

BRUSH AND BLOWERS TO WORK SAND INTO THE HOLES AND GRASS

FERTILIZER APPLICATION TO PROMOTE RECOVERY

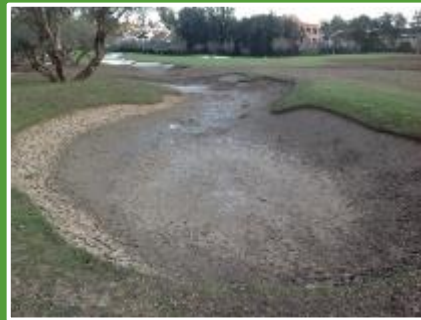
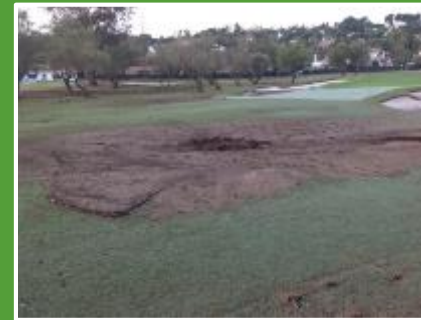
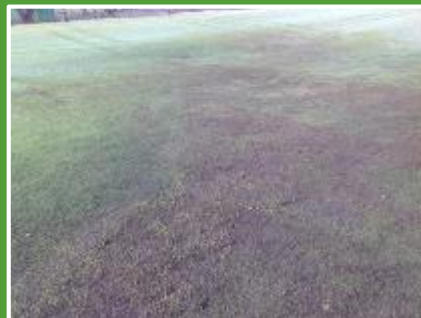
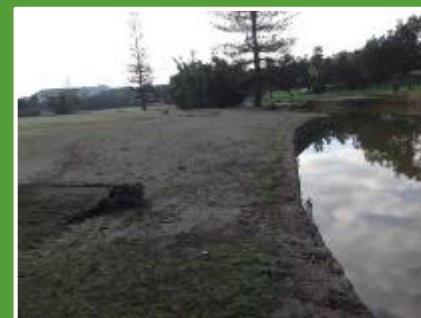
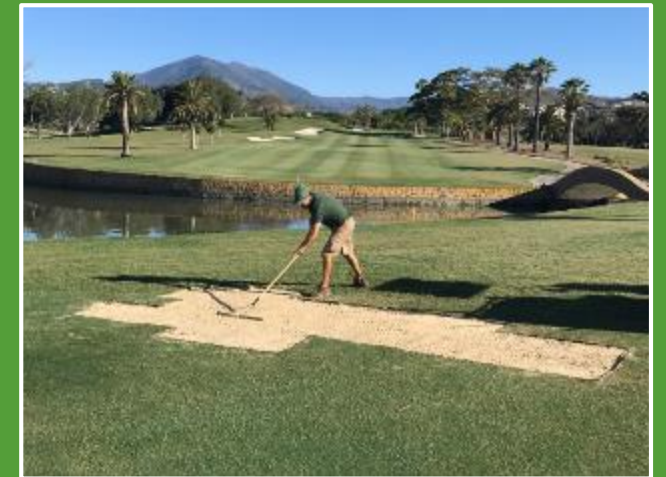
SODDING WORK

2016 FLOODS LEFT ON SOME FAIRWAYS AND ROUGHS A LAYER OF MUD THAT WAS CLEAN OUT OF THE SURFACE. STILL A LAYER OF SEVERAL MILLIMETERS OF MUD WAS LEFT THAT SEALED THE ROOT ZONE, BLOCKING THE FLOW OF OXYGEN AND WATER, AND REDUCING DRAINAGE

IN THESE AREAS, MAINLY IN THE LOWER SPOTS, THIS LAYER HAS BEEN REMOVED AND REPLACED WITH SOD FROM OUR NURSERY

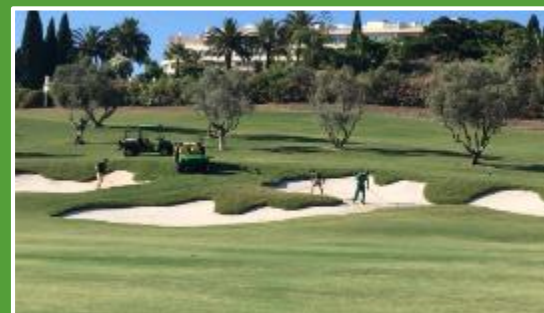
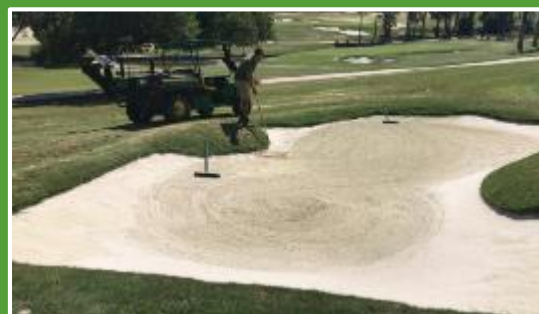
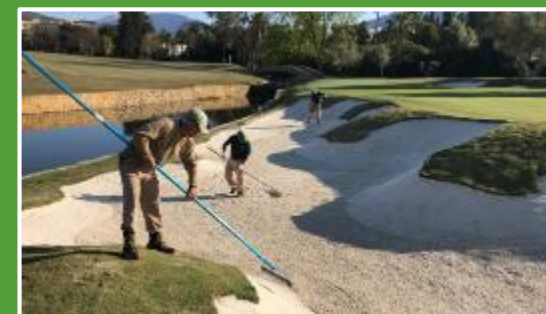
BUNKERS CHECK OUT

REGULAR CHECK OF BUNKER SAND DEPTH IS CARRIED OUT

RECYCLED WATER USED FOR IRRIGATION CONTAMINATES THE UPPER LAYER OF THE SAND. IN THE MORE AFFECTED AREAS THIS LAYER IS CLEANED AND REPLACED WITH NEW SAND IF NECESSARY

FINALLY, DEBRIS FROM AERATION IS REMOVED AND BUNKERS ARE PREPARED FOR PLAY

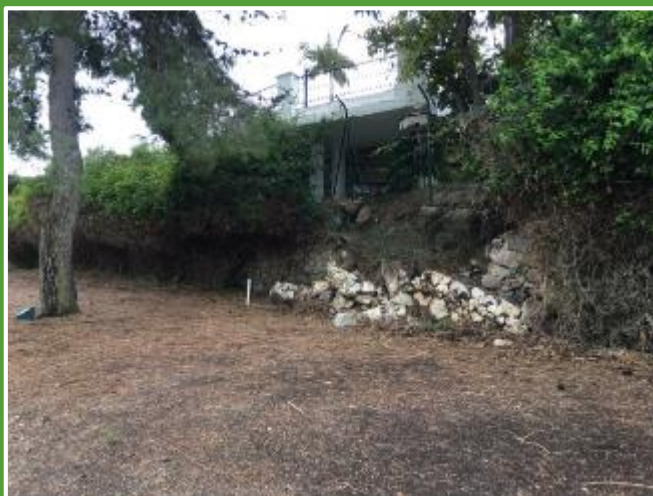
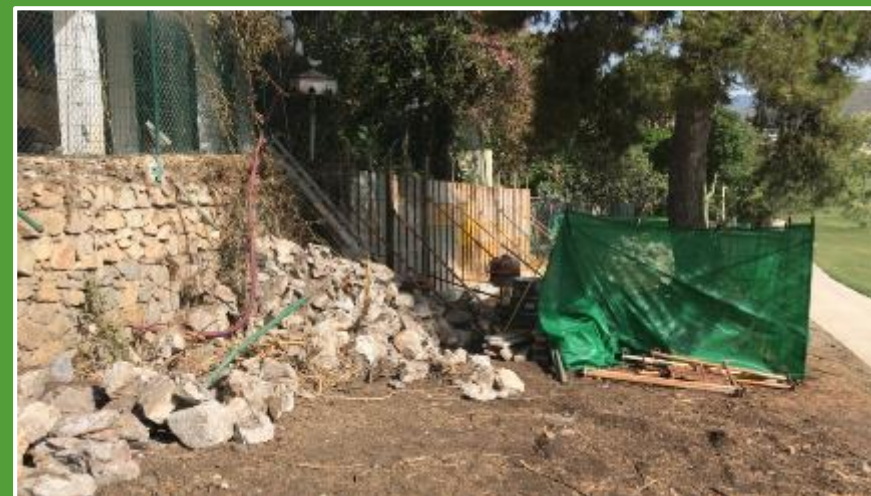
NEIGHBOURHOOD WORKS

ONCE THE COURSE IS CLOSED, WE ENCOURAGE NEIGHBOURS TO DO THOSE WORKS IN THEIR PREMISES AFFECTING THE COURSE BOUNDARY. THE MORE COMPLICATED WORKS IN THE WALL AT 4TH HOLE WERE DONE DURING THIS WEEK

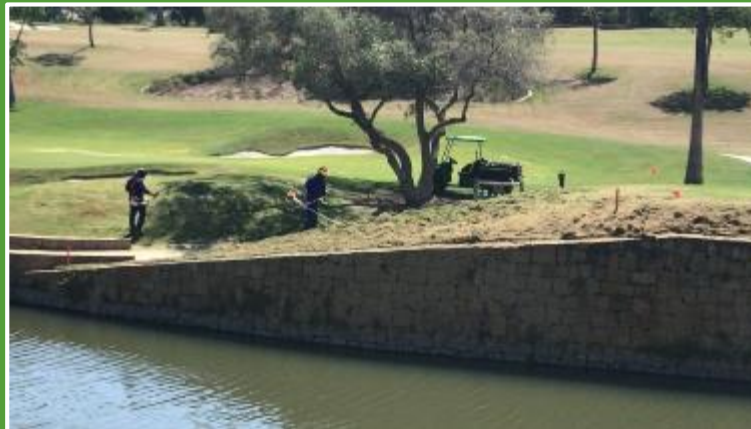
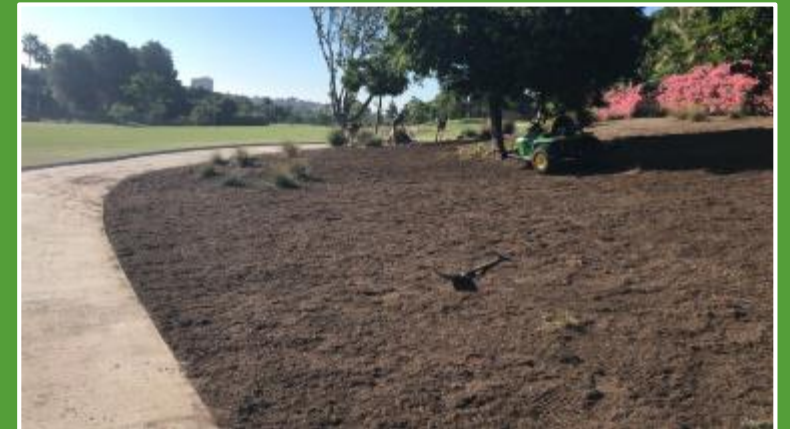
OTHER JOBS

STEEP AREAS WITH GRASS (BUNKERS, SLOPES) TEND TO BUILD UP THATCH. FOR THIS REASON, THEY NEED AN ANUAL AGGRESSIVE CUT

NATURAL AREAS WITH NO TURF ARE CLEANED AND FILLED WITH NEW MULCH

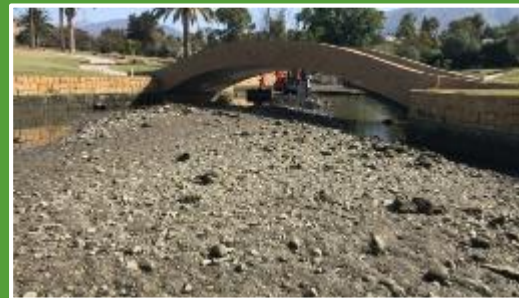
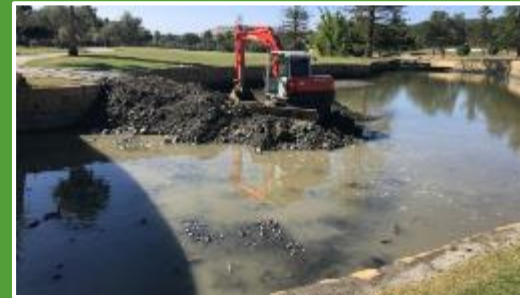
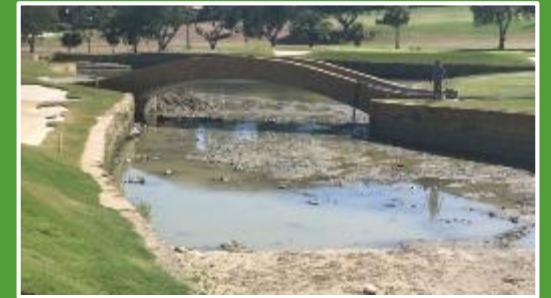
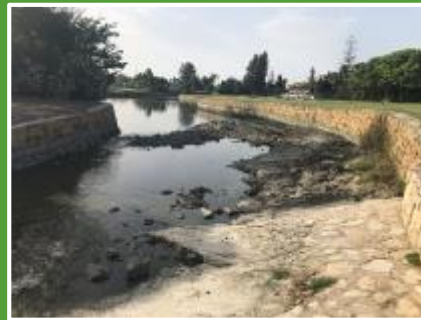
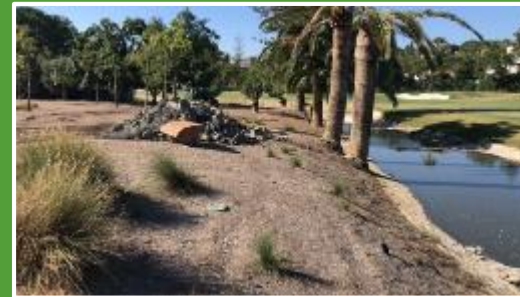
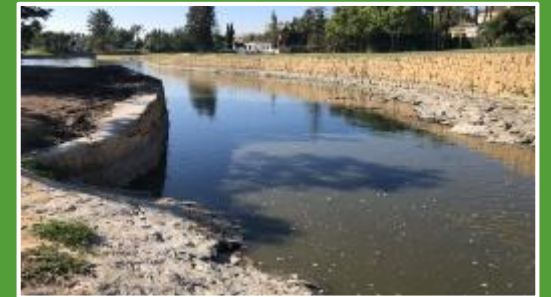
CLEANING LAKES

DURING 2016 FLOODS, GREAT AMOUNTS OF DEBRIS WERE DELIVERED IN THE ENTRANCE OF LAKES AT HOLES 12 AND 15

SINCE WE GOT HEAVY EQUIPMENT ON SITE FOR THE RENOVATION OF THE CREEK AT 17TH GREEN, IT WAS THE RIGHT TIME TO REMOVE IT OUT. THIS MATERIAL WILL BE REUSED IN OUR PREMISES

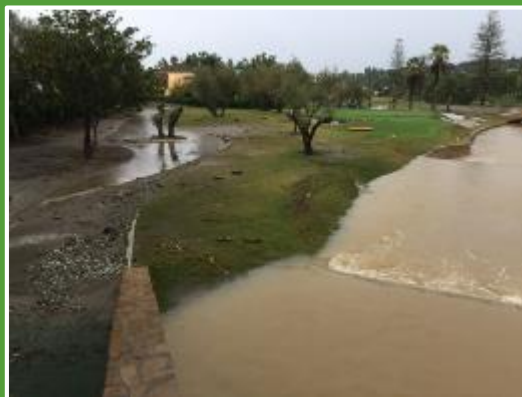
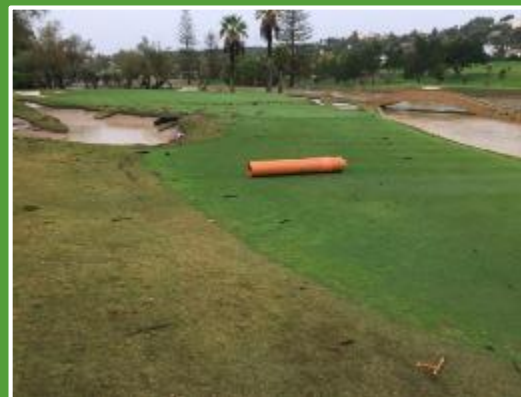
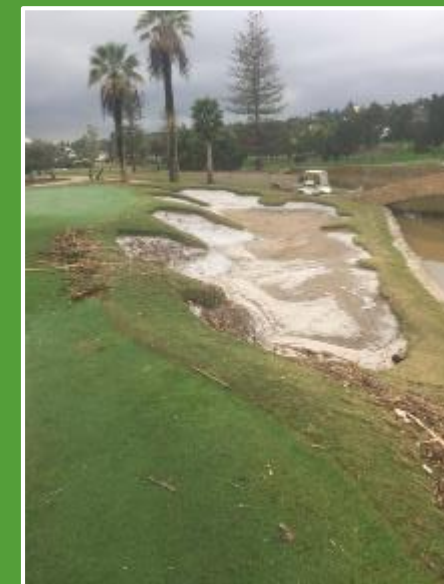
RENOVATION AT 17TH CREEK

TO MINIMIZE DAMAGE ON 17TH GREEN IN EVENTUAL FUTURE FLOODS, THE STUDY CONDUCTED BY A SPECIALIZED ENGINEERING RECOMMENDED CORRECTIVE MEASURES IN THE CREEK COURSE

DAMAGES ON 17TH GREEN, APPROACHES AND BUNKERS WERE SEVERE, PRESENTING A MUD DEPOSITION AND EROSIONS IN MANY AREAS

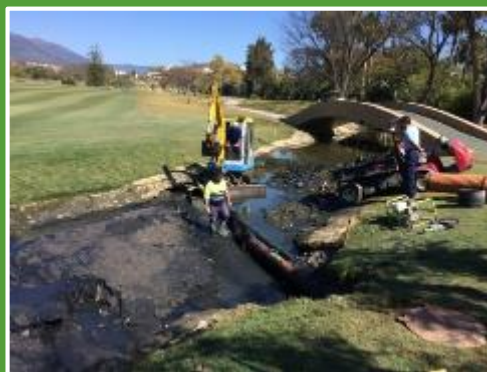
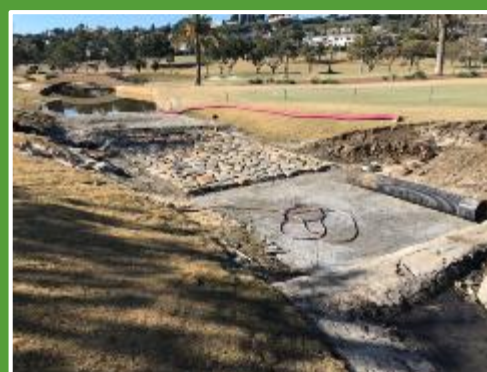
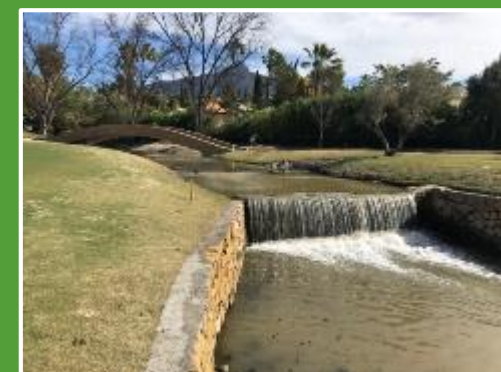
RENOVATION AT 17TH CREEK

JOBS TO WIDEN THE CREEK COURSE WERE NOT POSSIBLE UNTIL REPAIR OF A BROKEN SEWAGE LINE BY THE MUNICIPALITY

A FIRST REFURBISHMENT OF THE BANKS WERE DONE

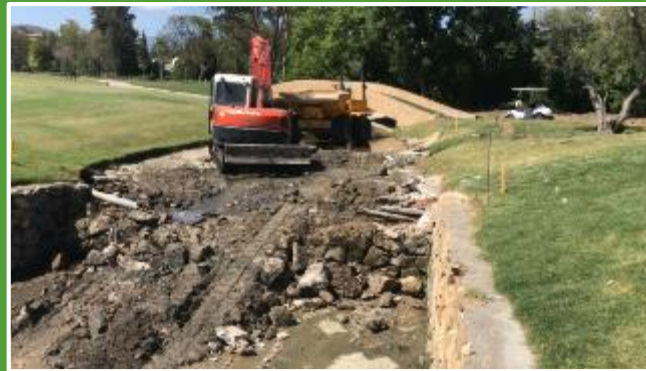
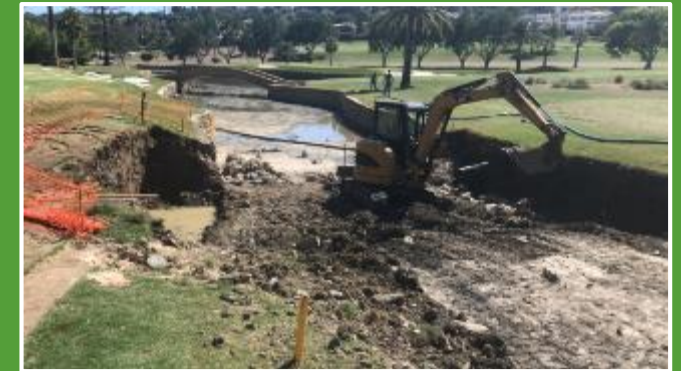
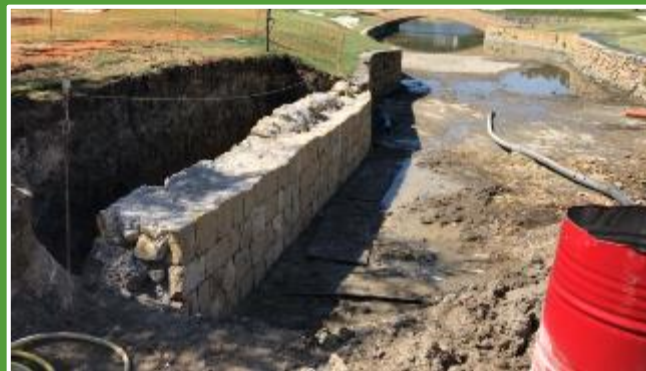
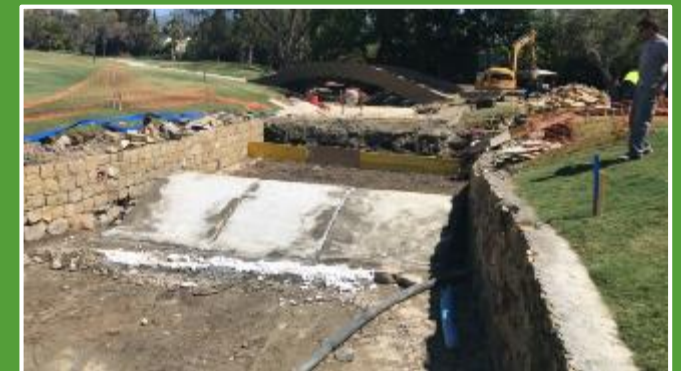
RENOVATION AT 17TH CREEK

DURING MAINTENANCE WEEK, FOR SAFETY REASONS, THE HEAVY WORK CLOSER TO THE LINE OF PLAY WERE CARRIED OUT

THE PROYECT INCLUDES A CHANGE IN THE PONDS LEVEL, REDESIGN OF THE WEIRS FOR OTHERS WITH A BETTER SHAPE FOR A MAXIMUM WATER EVACUATION. CREEK COURSE ALSO IS WIDENED

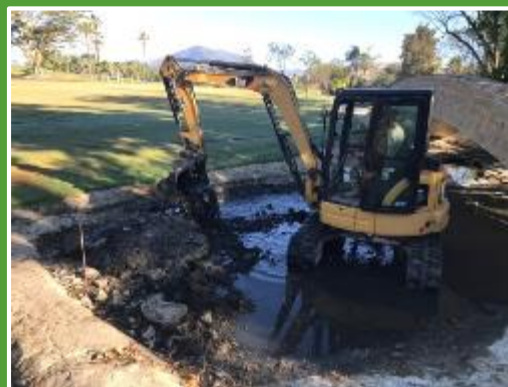
RENOVATION AT 17TH CREEK

CREEK BOTTOM IS CLEARED REDUCING TURBULENCE TO MAXIMISE FLOW

PROTECTION OF THE WALL BEFORE THE BRIDGE IS REINFORCED WITH A STONE WALL
